99780-S2R, RF Coil Assembly, Resonator, HE-VHE Refurbishment

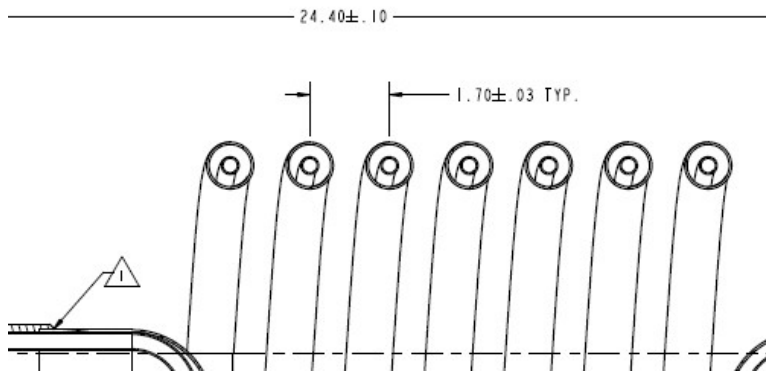
Our initial evaluation ensures the coil overall length and spacing relationship and individual coil spring out can be returned to original spec.

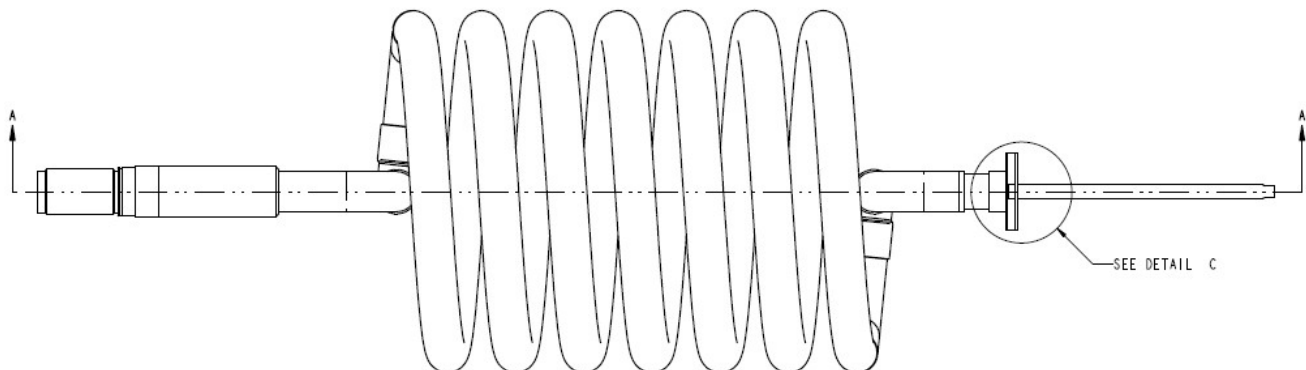
We can do some correction at the elbows, it is a second level repair if correction requires replacement of both elbows.

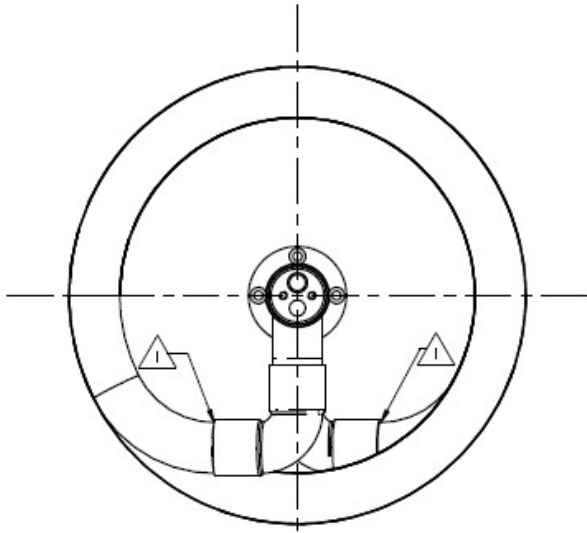
We do not have ability to repair the small cooling tube, if that cannot be used as is, then the refurb is DOA.
