A Resource for Semiconductor Manufacturers

## **CDO Liner Assembly**

## Glemco Customized Design CDO Showerhead Assembly

## CDO Flange Assembly With Demisters

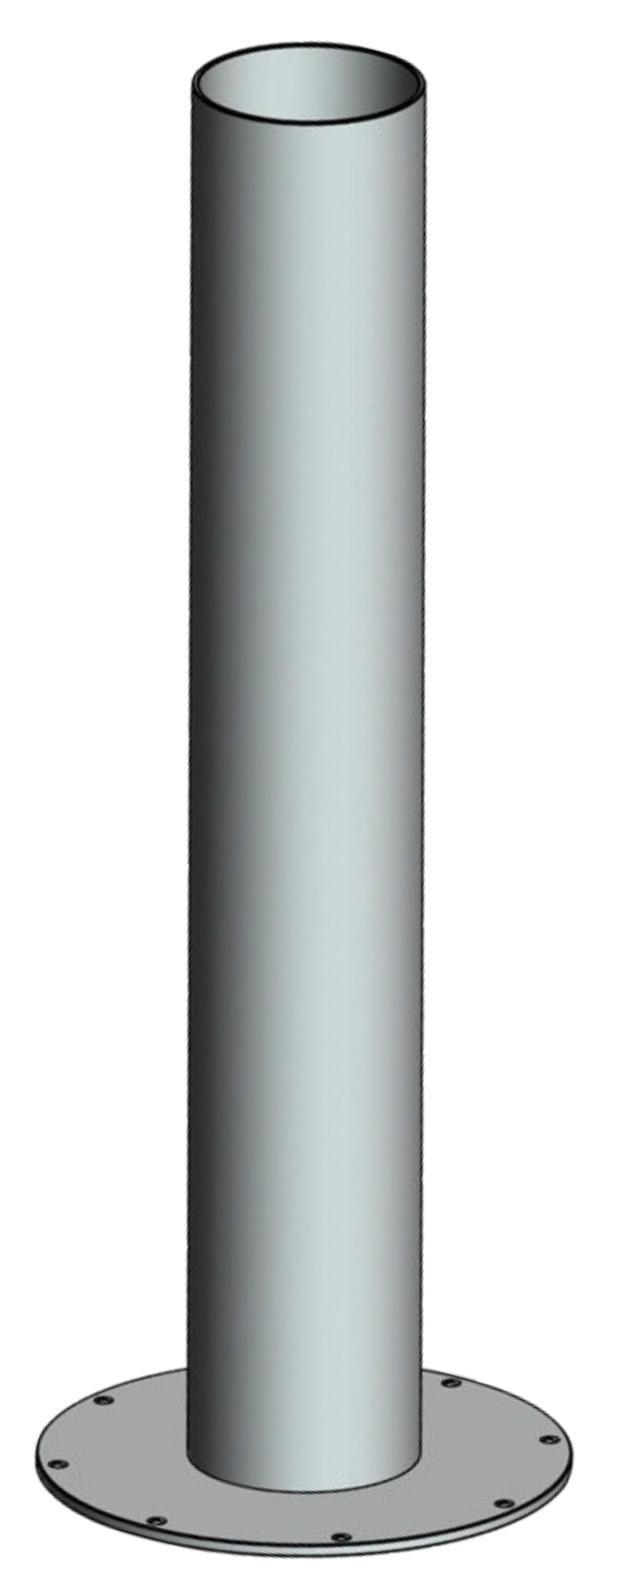
Item	P/N	Description	OEMs	Qty
1	45570	CDO Liner	423-57-003	1
Glemco offers	s improvemei	nts, modifications, or alternatives to standard OEM replacement con	nponents as indicated in red through	out this
	PO Box 21	7 Leander, TX USA 78646-0217 • 800-621-9598 • sales@g	lemco.com • www.glemco.com	
			G	30-047PH1

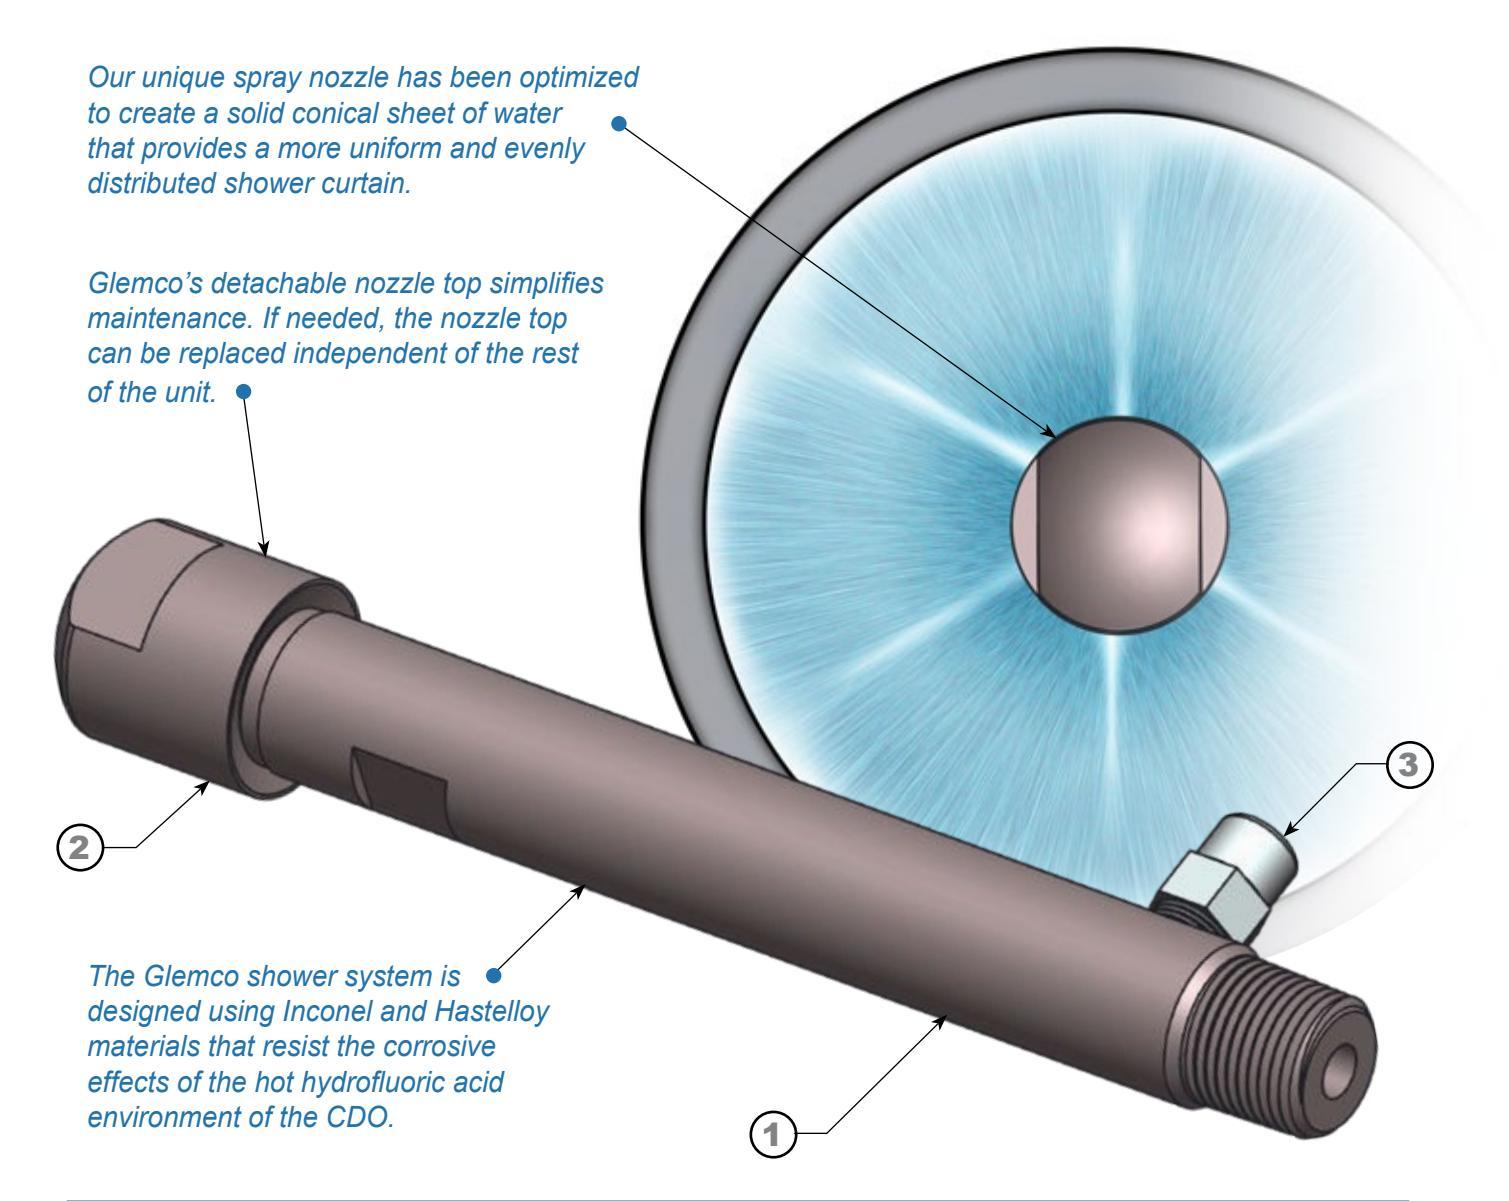
The standard OEM shower has a fixed shower head that provides an inefficient shower curtain inside the CDO. It's small tube can become clogged during use, which limits scrubber effectiveness. Also, it's welded design requires that the entire unit be replaced if it becomes clogged.

Glemco introduces an upgraded shower head assembly for the CDO Abatement System, that is designed to increase productivity and improve performance with these advancements...

Item	P/N	Description	OEMs
1	45571-1	Showerhead Body	No OEM Reference
2	45571-2	Spray, Cone	No OEM Reference
3	8B157	Fog Nozzle	No OEM Reference

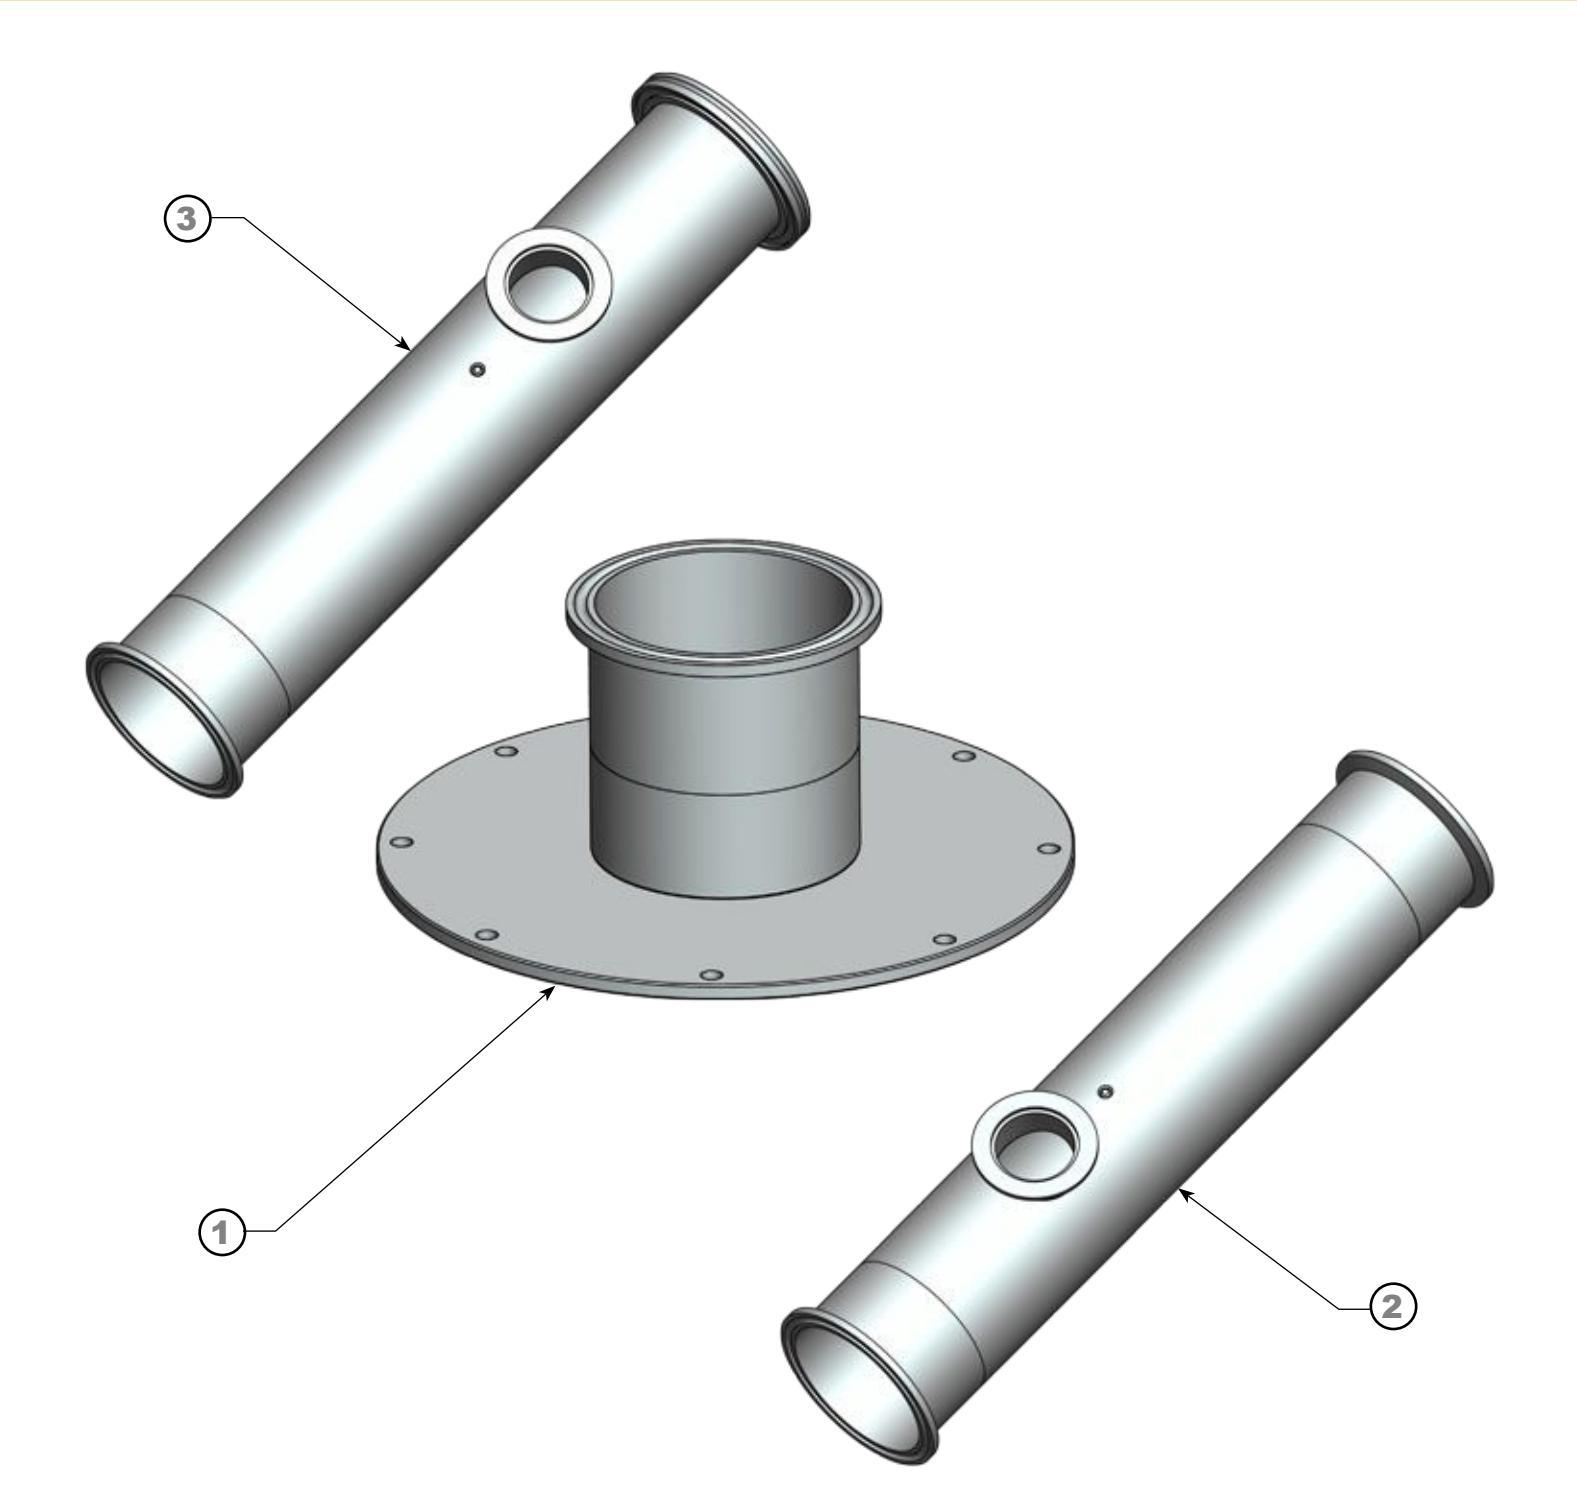
Item	P/N	Description	OEMs	Qty
1	45574S	CDO Flange Assembly	No OEM Reference	1
2	45575S	Lower Demister	No OEM Reference	1
3	45576S	Upper Demister	No OEM Reference	1
